**NATIONAL AUDIT OFFICE OF THE GAMBIA**

# **PERFORMANCE AUDIT REPORT**

**THE PROVISION OF WATER IN URBAN, PERI-URBAN AND  
PROVINCIAL GROWTH CENTRES BY NAWEC**

**NOVEMBER 2022**

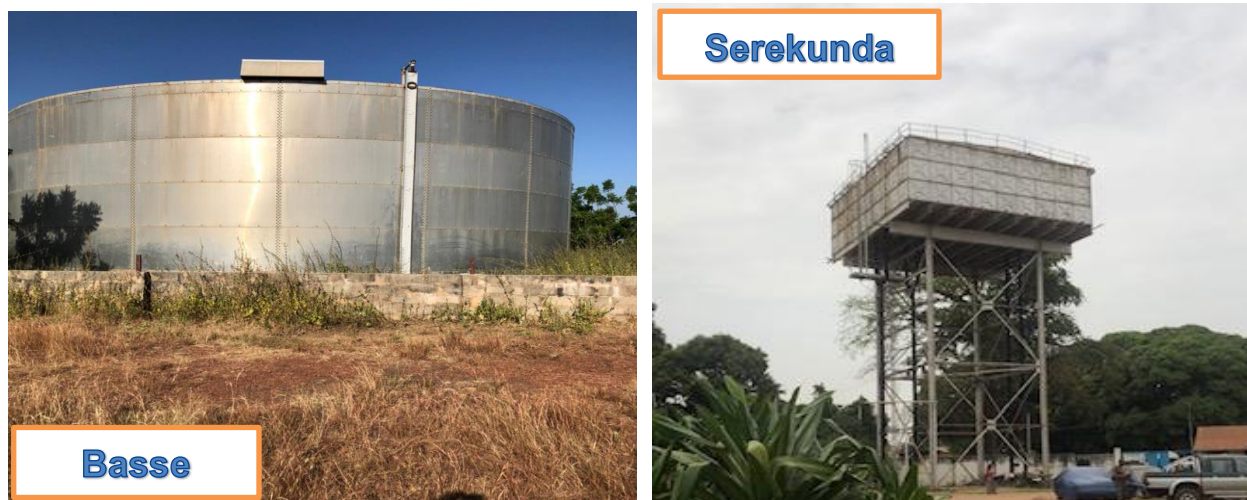
As shown in table 3 above, 44% of the elevated tanks were bypassed due to the excess demand, faulty liners, structural problems, and old age. Some of these causes were corroborated by the water and sanitation in the Greater Banjul Area (WASIB) project feasibility study. Picture 1 shows the non-functional elevated tanks at Basse and Serekunda water treatment plants.

Picture 1: Non-functional water tank at Basse water facility and Serekunda Treatment Plant

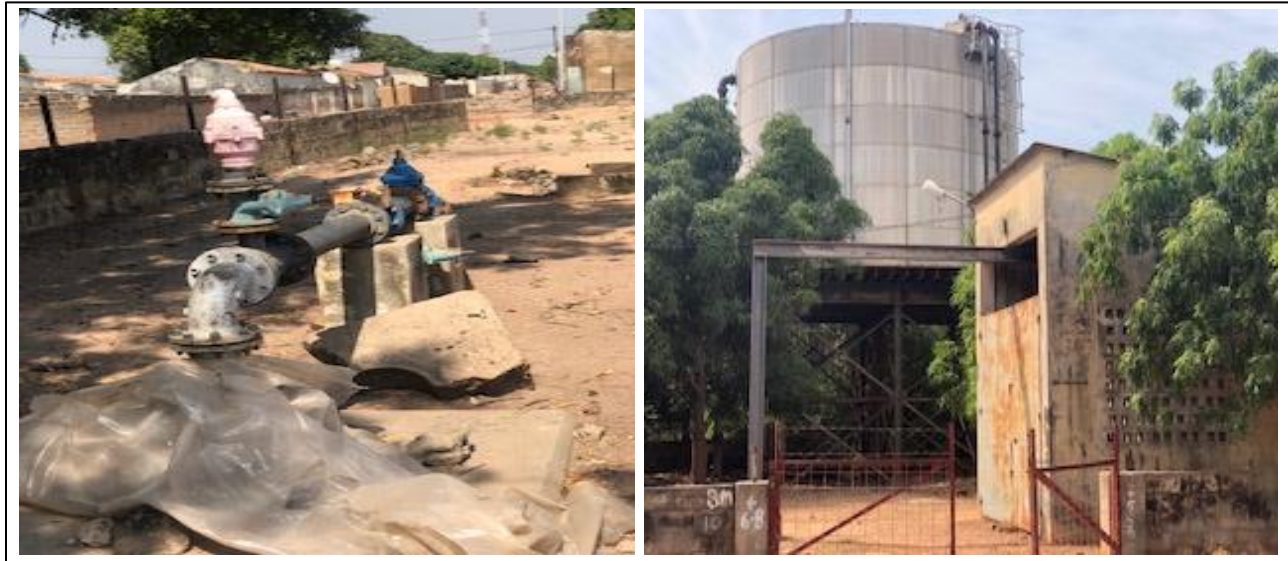
Picture 2: The unprotected water facility at Farafenni (Left) and Mansakonko water facility (right)

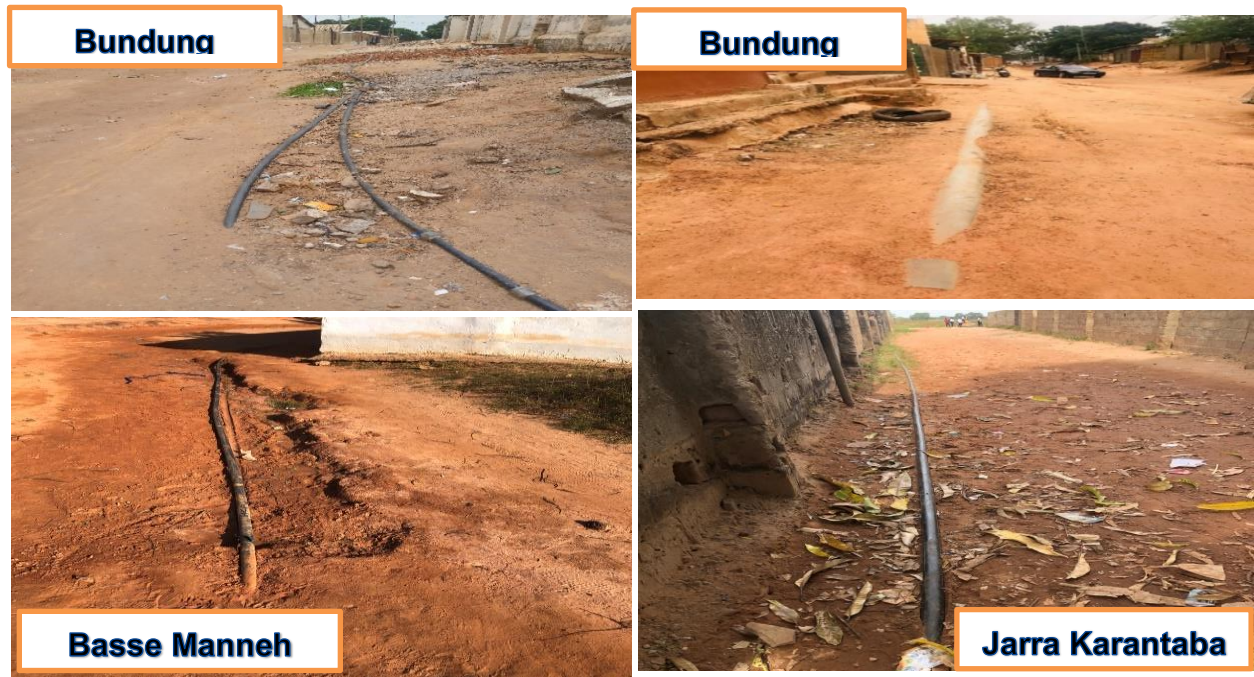
Picture 4: NAWEC’s exposed distribution pipe (top Left), main pipe (top right) in Bundung and exposed distribution pipe (Bottom left) exposed distribution pipe at Jarra Karantaba (Bottom right)

NAWEC’s Water Division Management informed us that the exposure is sometimes caused by soil erosion, or the pipes were not laid at the appropriate depth during installation. This assertion was confirmed during our site visits as seen in the above pictures (3 and 4) that pipes were not properly buried as required. In addition, during an interview, the management of Water Division acknowledged that NAWEC has not set up a monitoring team to follow up on its ground works.<sup>40</sup>

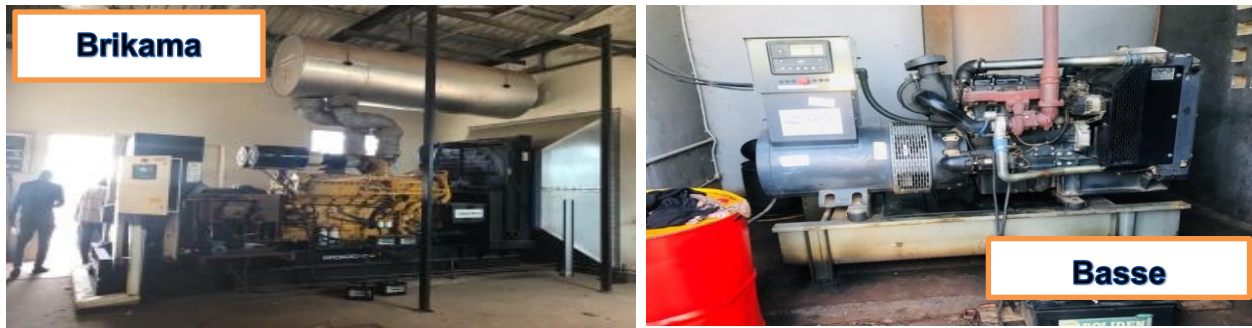
**Picture 5: Non- functional Standby Generators at Brikama and Basse water treatment plant.**

According to the Water Division management, NAWEC has failed to repair its generators due to financial constraints. However, the audit team was not provided with any document to back this claim.

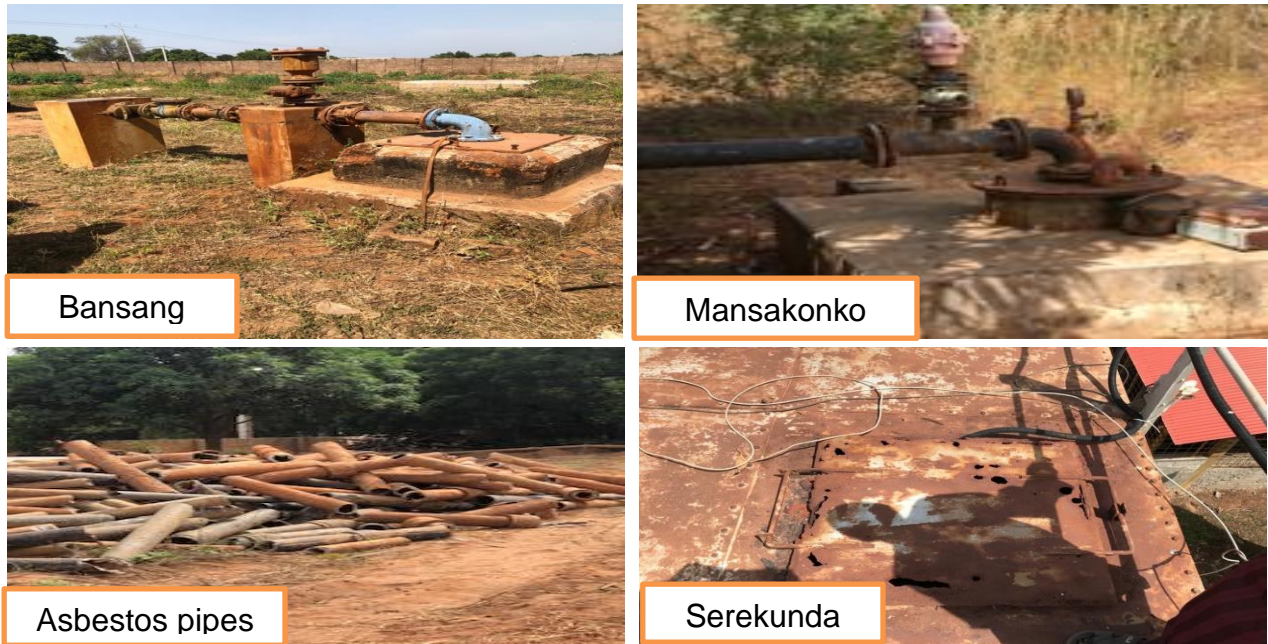
Picture 6: Corroded boreholes at Bansang water facility (top left) and Mansakonko (top right), some of the replaced asbestos pipes placed at Faraja water treatment plant and reservoir at Serekunda water treatment plant (bottom right)

This was due to the company's failure to establish strategies for replacing old infrastructures. Corroded aged infrastructures pose a high risk of failure, resulting in service interruptions and water quality with a bad taste, colour and contamination. **Appendix 8:** Showing 74 boreholes and their ages their ages.

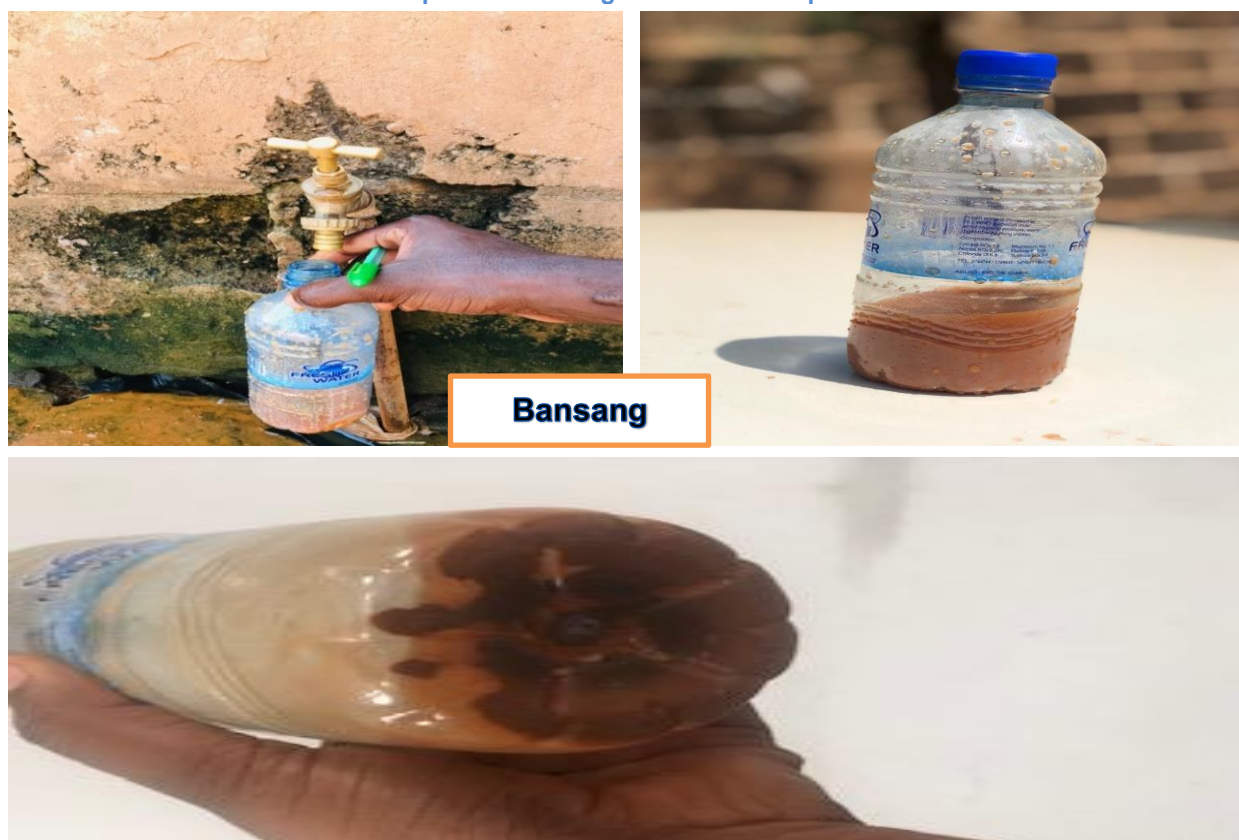
During the inspection of the Bansang Water Treatment Plant, the audit team collected a water sample from a tap inside the Treatment Plant as shown in Picture 7.

**Picture 7: Water obtained from the tap in the Bansang water treatment plant**

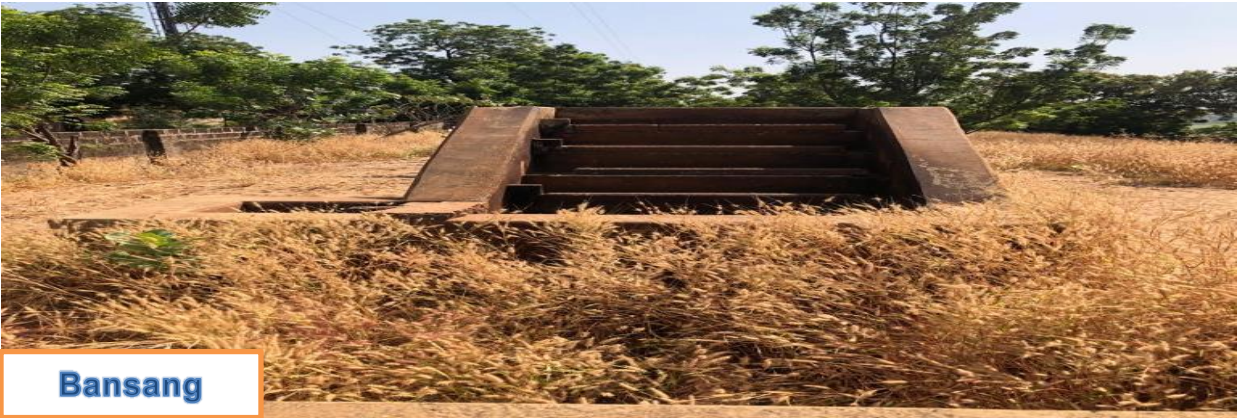
Review of DWR Quarterly Water Quality Monitoring Report revealed that in the third Quarter of 2018, the Bansang water PH level was calculated at 6.57 and this was when aeration was already carried out. However, it was calculated at 5.89 during the second quarter of 2021 when no aeration was carried out during the period. The picture below shows the abandoned aerator at the Bansang Water Treatment Plant.

Picture 8: Abandoned aerator at Bansang Water Treatment Pant

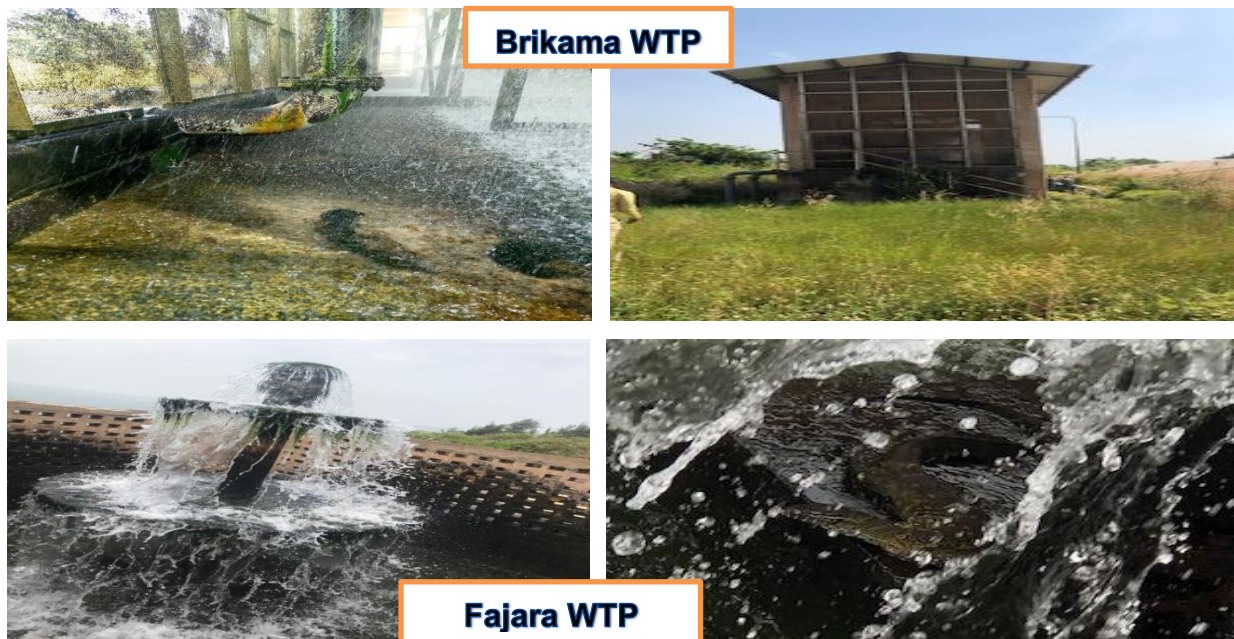
**Picture 9: Condition of the aerator at Brikama Water Treatment Plant (Top left and top Right) and aerator condition at Fajara Water Treatment Plant showing a reptile (Monitor Lizard) inside the aerator.**

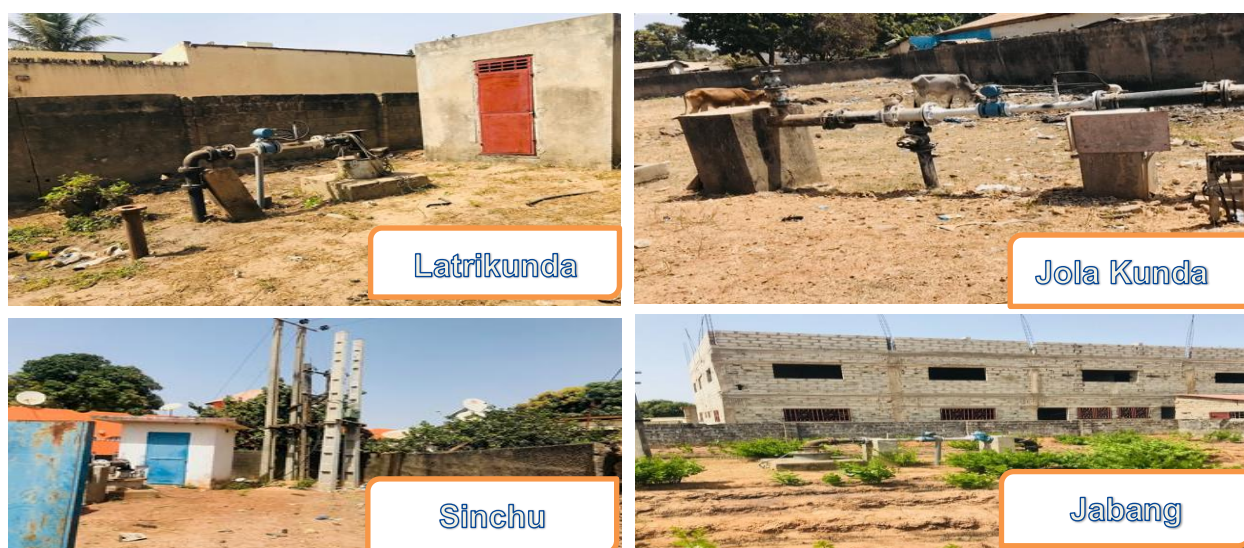
**Picture 10: NAWEC boreholes encroached by settlements (Top left PN6(Sinchu), Top right BH12 (Jola Kunda) and BH 18(Latrikunda) all link to the Serekunda WTP and down right is SS6 of Sukuta WTP.**
