NATIONAL AUDIT OFFICE OF THE GAMBIA

PERFORMANCE AUDIT REPORT

**THE PROVISION OF WATER IN URBAN, PERI-URBAN AND
PROVINCIAL GROWTH CENTRES BY NAWEC**

NOVEMBER 2022

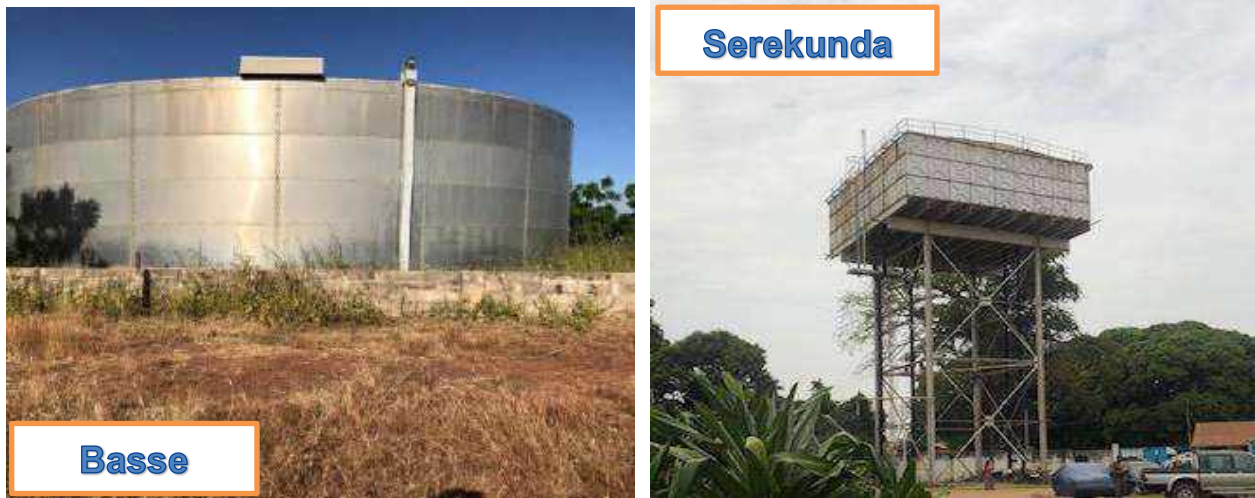
As shown in table 3 above, 44% of the elevated tanks were bypassed due to the excess demand, faulty liners, structural problems, and old age. Some of these causes were corroborated by the water and sanitation in the Greater Banjul Area (WASIB) project feasibility study. Picture 1 shows the non-functional elevated tanks at Basse and Serekunda water treatment plants.

Picture 1: Non-functional water tank at Basse water facility and Serekunda Treatment Plant

Consequently, the distribution system was unable to maintain the pressure needed to reach certain areas, thus, resulting in few hours of water supply or no water supply in most of the service areas. In most areas water is available during the night or mornings lasting for an hour or two. Furthermore, the bypass affects the efficiency of the booster pumps as they are used continuously to pump water.

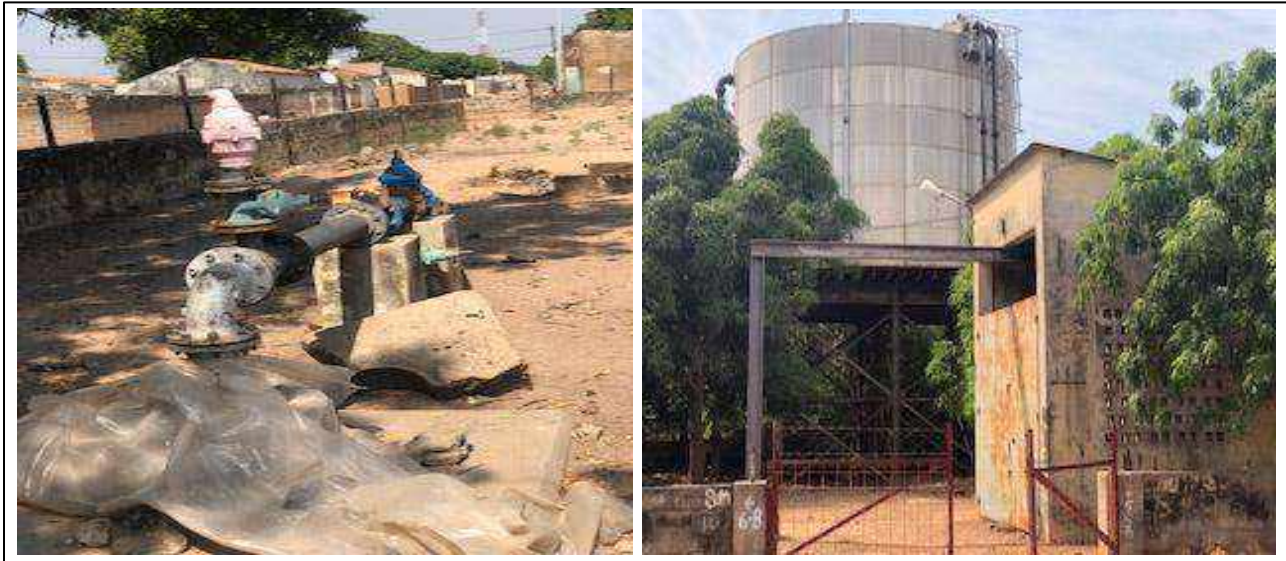
During the period under review, we noted that some of the company's facilities were not well secured. For example, some of the facilities visited were not provided with security guards and others were not provided with full perimeter fence including proper gates. The security of these facilities relies on the operating staff during working hours. The facilities are left unprotected when these staff close work. This gives license to intruders such as unscrupulous person (thieves) and other domestic animals to access these premises causing some damages to these company infrastructures and equipment.

Picture 2: The unprotected water facility at Farafenni (Left) and Mansakonko water facility (right)

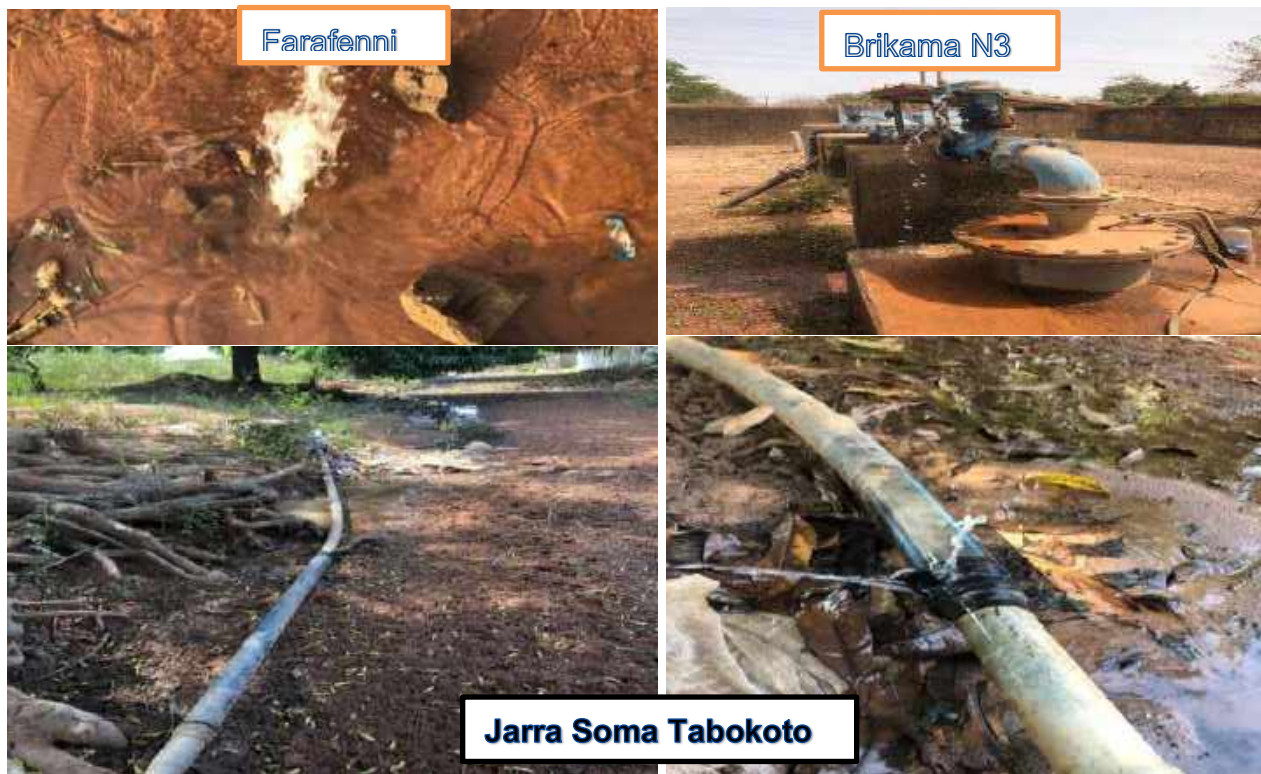
The pictures below show some of the areas affected with water leakages due to burst pipes, leakages at the boreholes and exposed pipes on the surfaces of the sand.

Picture 3: Burst pipes in Farafenni (top) and Mansakonko (down)

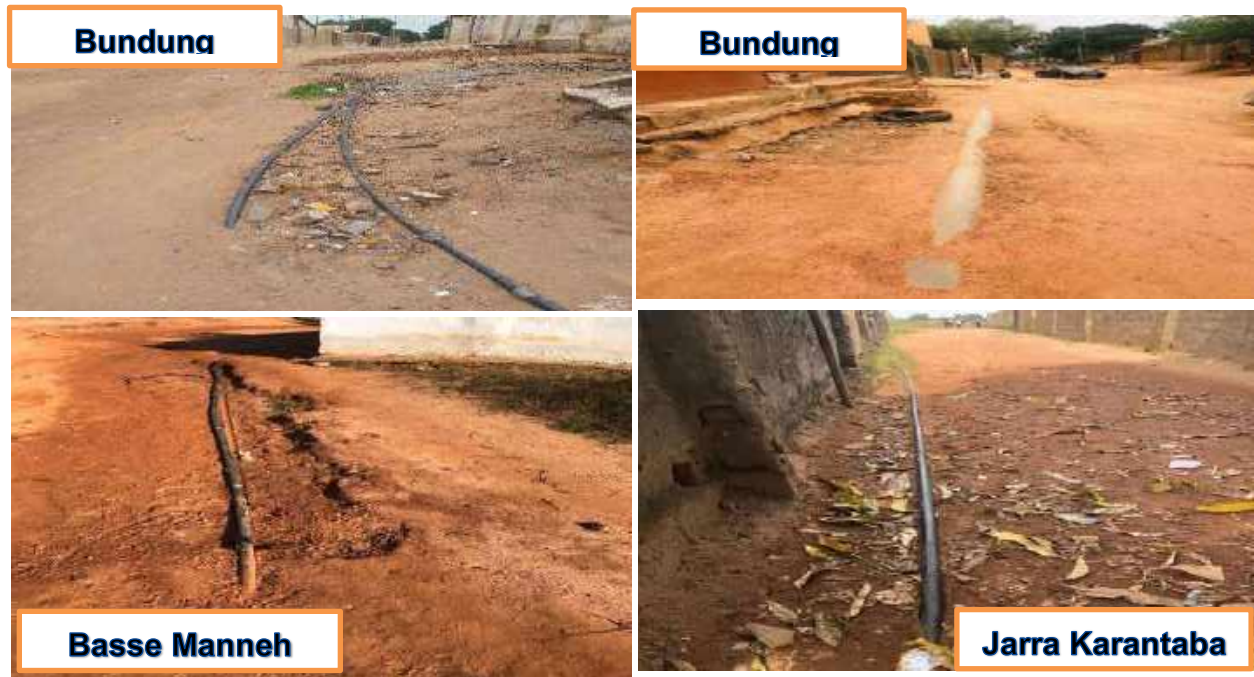
Picture 4: NAWEC’s exposed distribution pipe (top Left), main pipe (top right) in Bundung and exposed distribution pipe (Bottom left) exposed distribution pipe at Jarra Karantaba (Bottom right)

NAWEC’s Water Division Management informed us that the exposure is sometimes caused by soil erosion, or the pipes were not laid at the appropriate depth during installation. This assertion was confirmed during our site visits as seen in the above pictures (3 and 4) that pipes were not properly buried as required. In addition, during an interview, the management of Water Division acknowledged that NAWEC has not set up a monitoring team to follow up on its ground works.⁴⁰

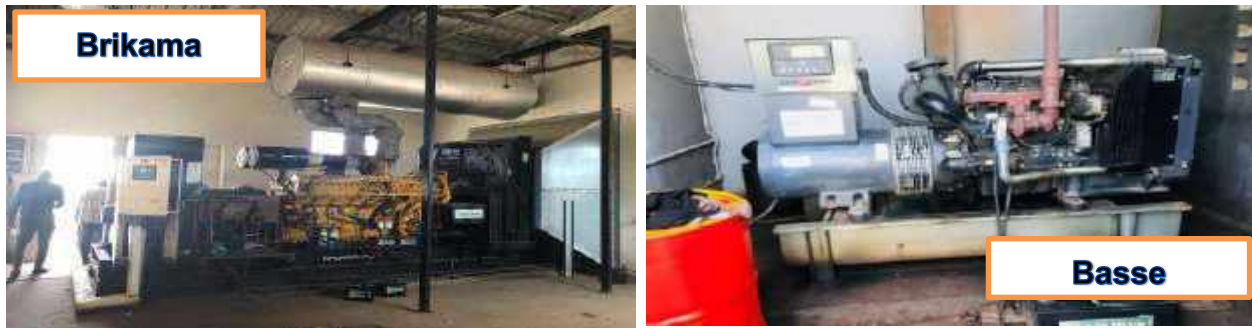
During our inspections at the rural NAWEC water production facilities, we confirmed that the Generator at Basse Water Production Facilities which is responsible for almost 7 villages was not functional at the times of our visit on 24 November 2021. We also learnt that only 2 out of the 5 boreholes at Fajara water treatment plant were linked to the standby Generator. Through interviews and physical verifications, we found that 44 out of the 60 boreholes visited were not linked to any generator as shown in chart 7 and therefore leads to service interruption whenever there is power outage.

Picture 5: Non- functional Standby Generators at Brikama and Basse water treatment plant.

According to the Water Division management, NAWEC has failed to repair its generators due to financial constraints. However, the audit team was not provided with any document to back this claim.

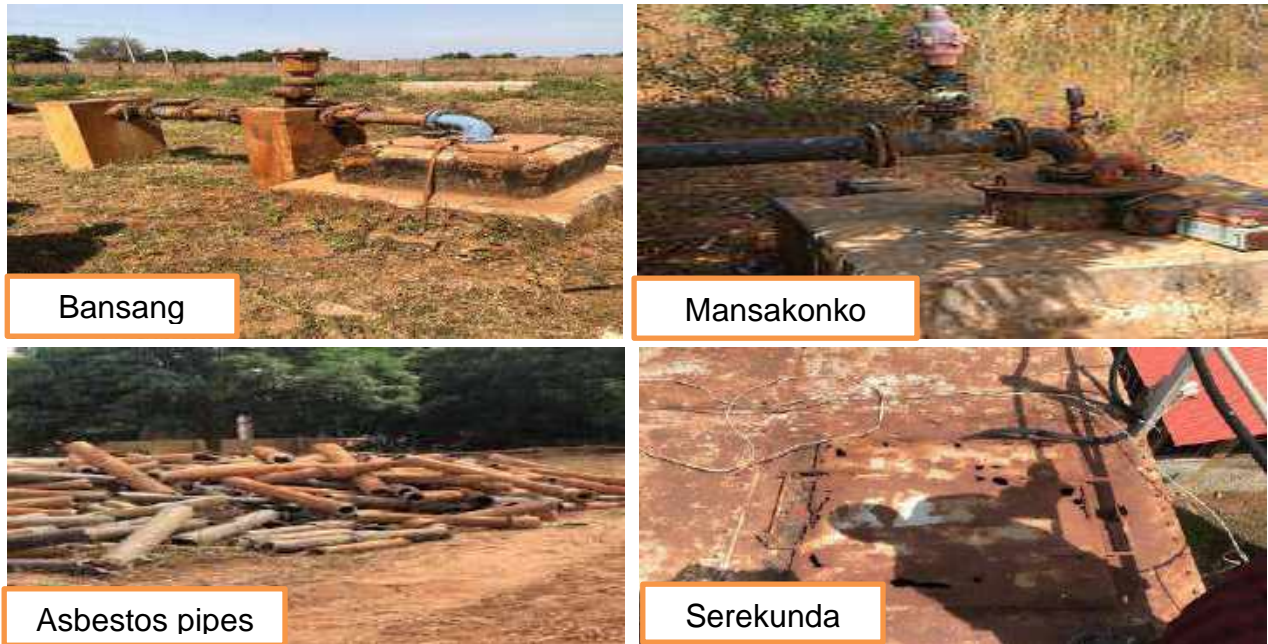
Picture 6: Corroded boreholes at Bansang water facility (top left) and Mansakonko (top right), some of the replaced asbestos pipes placed at Faraja water treatment plant and reservoir at Serekunda water treatment plant (bottom right)

This was due to the company's failure to establish strategies for replacing old infrastructures. Corroded aged infrastructures pose a high risk of failure, resulting in service interruptions and water quality with a bad taste, colour and contamination. **Appendix 8:** Showing 74 boreholes and their ages their ages.

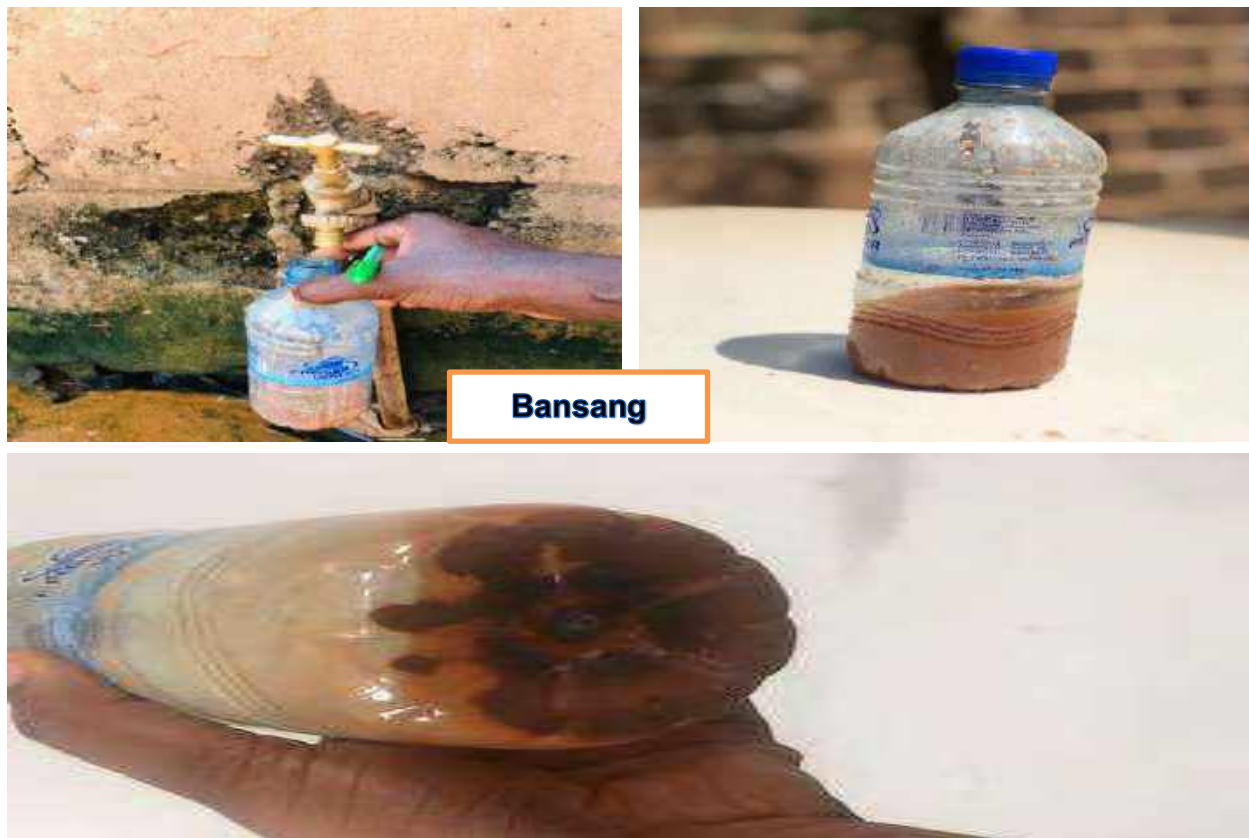
During the inspection of the Bansang Water Treatment Plant, the audit team collected a water sample from a tap inside the Treatment Plant as shown in Picture 7.

Picture 7: Water obtained from the tap in the Bansang water treatment plant

High iron content in water promotes bacterial growth in water production and distribution system, iron overload can cause hemochromatosis in humans which causes damage to

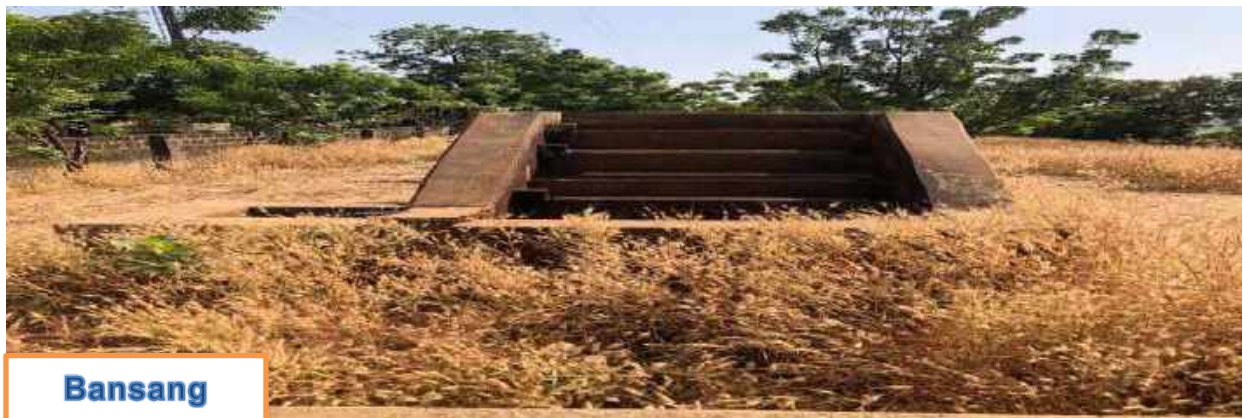
Review of DWR Quarterly Water Quality Monitoring Report revealed that in the third Quarter of 2018, the Bansang water PH level was calculated at 6.57 and this was when aeration was already carried out. However, it was calculated at 5.89 during the second quarter of 2021 when no aeration was carried out during the period. The picture below shows the abandoned aerator at the Bansang Water Treatment Plant.

Picture 8: Abandoned aerator at Bansang Water Treatment Pant

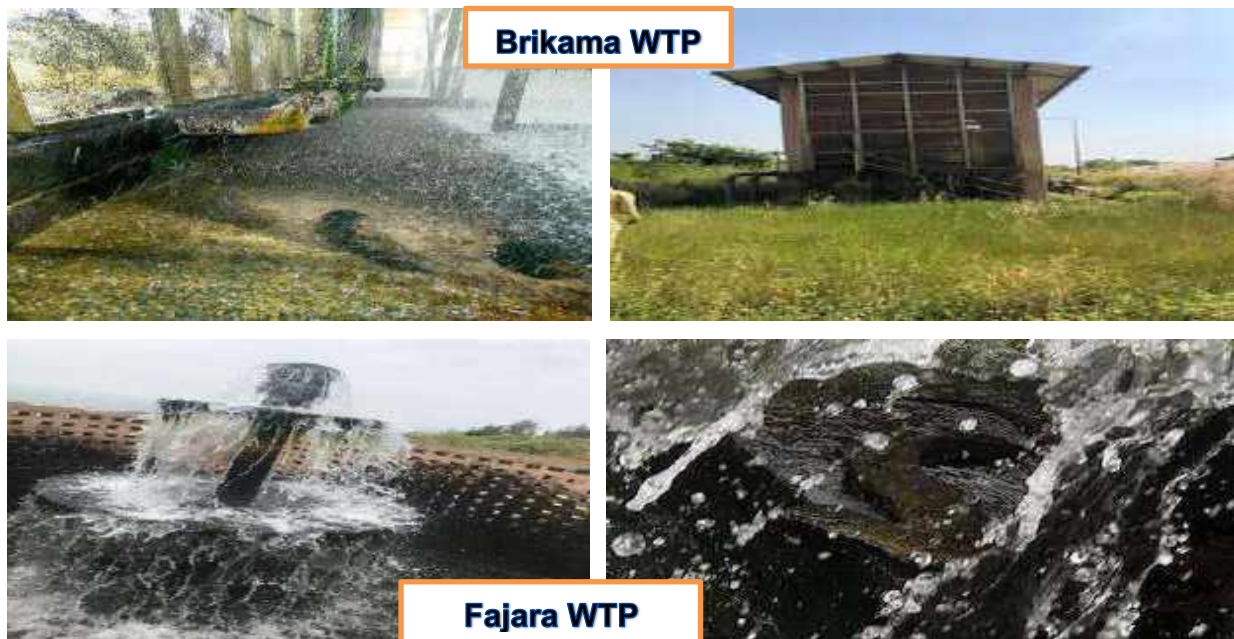
The unhygienic condition of the water facilities poses a high risk to the health of the consumers as the water is exposed to contaminants such as disease-causing microbes (bacteria). Exposed and unenclosed aerators attract birds, animals, reptiles, harmful objects, and bacteria; these can lead to water contamination and a high risk of supplying contaminated water to the population.

Picture 9: Condition of the aerator at Brikama Water Treatment Plant (Top left and top Right) and aerator condition at Fajara Water Treatment Plant showing a reptile (Monitor Lizard) inside the aerator.

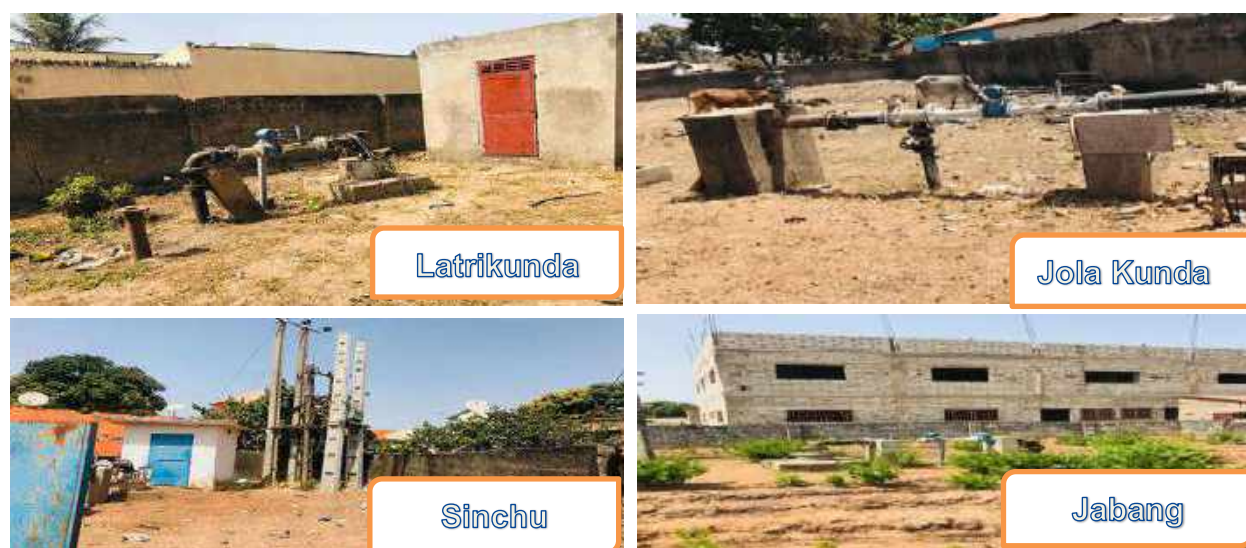
Picture 10: NAWEC boreholes encroached by settlements (Top left PN6(Sinchu), Top right BH12 (Jola Kunda) and BH 18(Latrikunda) all link to the Serekunda WTP and down right is SS6 of Sukuta WTP.

Encroached: We discovered that 31% of the NAWEC boreholes shared a fence with residents.
