**NATIONAL AUDIT OFFICE OF THE GAMBIA**

# **PERFORMANCE AUDIT REPORT**

**THE PROVISION OF WATER IN URBAN, PERI-URBAN AND  
PROVINCIAL GROWTH CENTRES BY NAWEC**

**NOVEMBER 2022**

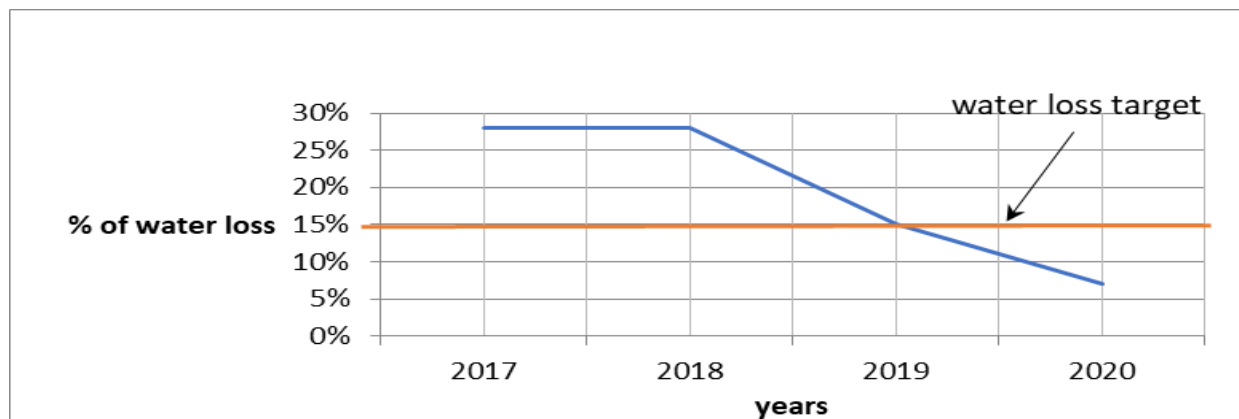
**Chart 5: Amount of water loss between 2017 and 2020** <sup>37</sup>

From the review of the water production figures provided by NAWEC Water Division, we noted that the company has improved on mitigating water losses to meet its 15% target. The trend over the years is shown in the chart below.

From the chart above it can be seen that from 2017 to 2020, the water loss percentage had decreased from 28% to 7%. However, it is important to note that these production figures were based on estimates because only about half of the boreholes were metered correctly as highlighted in section 4.2.2. This could have an impact on the accuracy of the reported water losses.

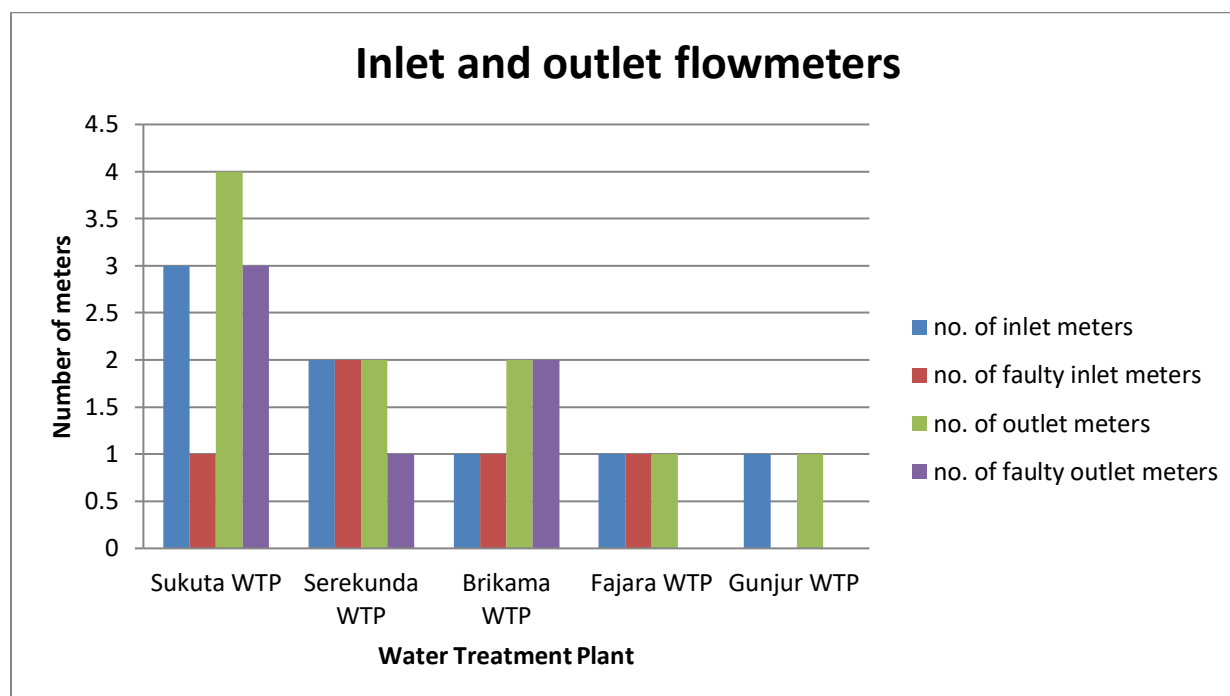
Chart 6 : Number of fault outlet and inlet flowmeters at water treatment plants and elevated tanks.

Furthermore, during an inspection of the inlet and outlet bulk water meters at the water treatment plants, the audit team noted that 11 out of 18 meters were faulty (5 inlets and 6 outlets). The functionality of flowmeters is shown in chart 6.

Additionally, an inspection of the inlet and outlet meters of 27 elevated tanks revealed that 15 elevated tanks had faulty inlet meters, 5 did not have inlet meters and 19 had faulty outlet meters.

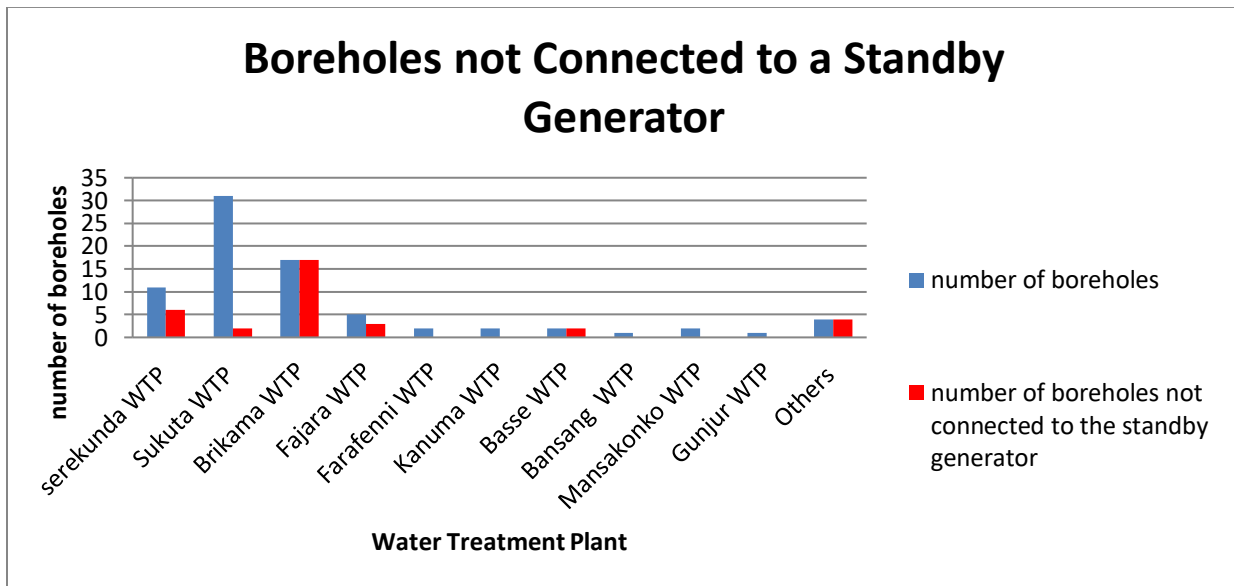
**Chart 7: Boreholes link to Standby Generators and those that are not linked.**

During our inspections at the rural NAWEC water production facilities, we confirmed that the Generator at Basse Water Production Facilities which is responsible for almost 7 villages was not functional at the times of our visit on 24 November 2021. We also learnt that only 2 out of the 5 boreholes at Fajara water treatment plant were linked to the standby Generator. Through interviews and physical verifications, we found that 44 out of the 60 boreholes visited were not linked to any generator as shown in chart 7 and therefore leads to service interruption whenever there is power outage.

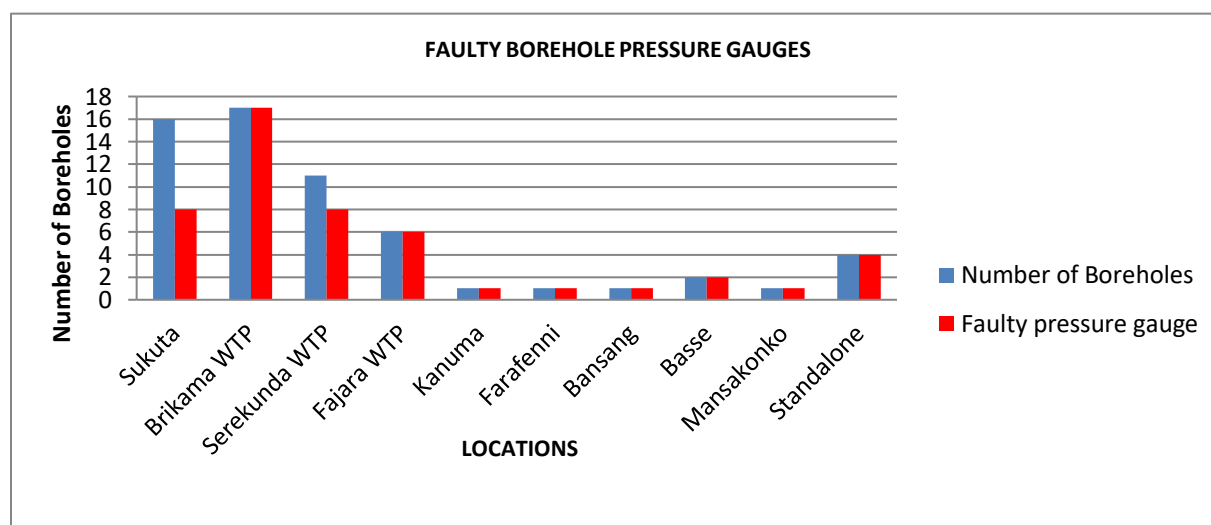
**Chart 8: Number of NAWEC boreholes pressure gauges and the faulty pressure gauges.**

Thus indicating that NAWEC is unaware of the pressure at which the rest of its boreholes are pumping water to the treatment plants or elevated tanks. The chart below shows the functionality of borehole pressure gauges.

Analysis of chart 8 above shows that 49 (representing 82%) of the pressure gauges installed at the boreholes were not working

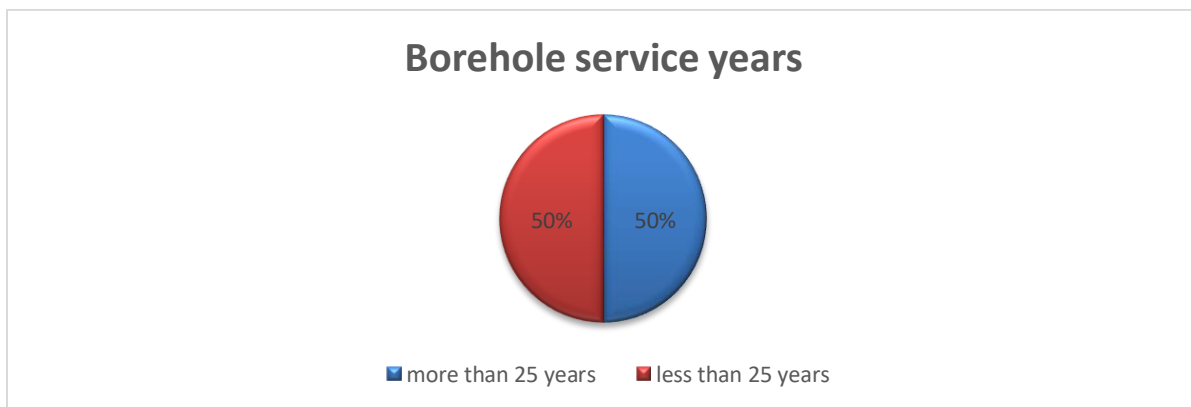
Chart 9: Borehole service years of 74 boreholes.

This was due to the company's failure to establish strategies for replacing old infrastructures. Corroded aged infrastructures pose a high risk of failure, resulting in service interruptions and water quality with a bad taste, colour and contamination. **Appendix 8:** Showing 74 boreholes and their ages their ages.

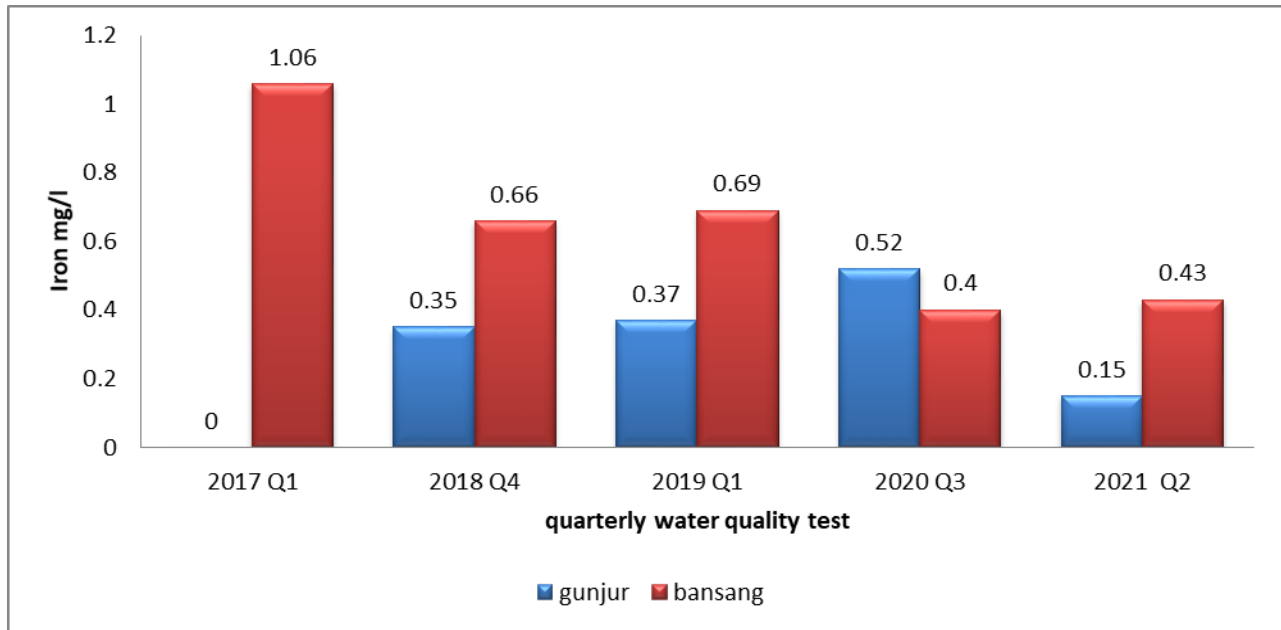
**Chart 10: Iron content in the water supplied to Bansang and Gunjur**

issue. Additionally, in an attempt to reduce the high levels of iron in Gunjur's water supply, NAWEC decommissioned one of the boreholes with high iron content in Gunjur, but no iron filtration system was installed in Gunjur's Water Treatment Plant. However NAWEC said they plan on taking water from another source mainly Busuranding.

The review of a sample of Quarterly Water Quality Test Reports by DWR during the period under review revealed that, despite the iron filtration system in Bansang, the water in Bansang continued to contain high levels of iron above the WHO standard for drinking water quality. Meanwhile in Gunjur, the iron content has been higher than the acceptable level in 2018 to 2020. However, in 2021 both the first and second quarter Water Quality Test Reports by DWR showed that the iron content in the water sample tested from Gunjur were below the acceptable level.

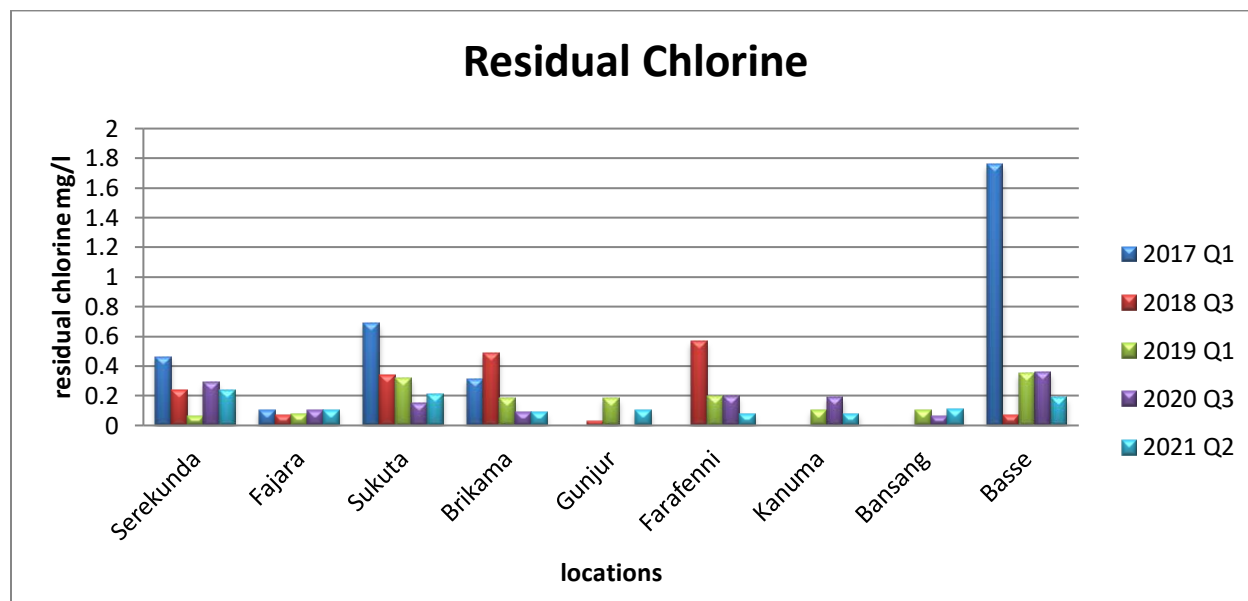
Chart 11: Residual chlorine test result in 85 locations in 2017 and 100 locations from 2018 to 2021.

Review of a sample of the Quarterly Water Quality Monitoring Reports prepared by the Department of Water Resources between 2017 to 2021 showed that an average of 76% of 100 locations tested did not meet the required minimum standard of residual chlorine in the water samples. Analysis of 5 samples of quarterly water quality tests presented is in the chart below.

Further analysis of the quarterly water test results during the period under review showed that the water sample of an average of 16 locations had no residual chlorine.

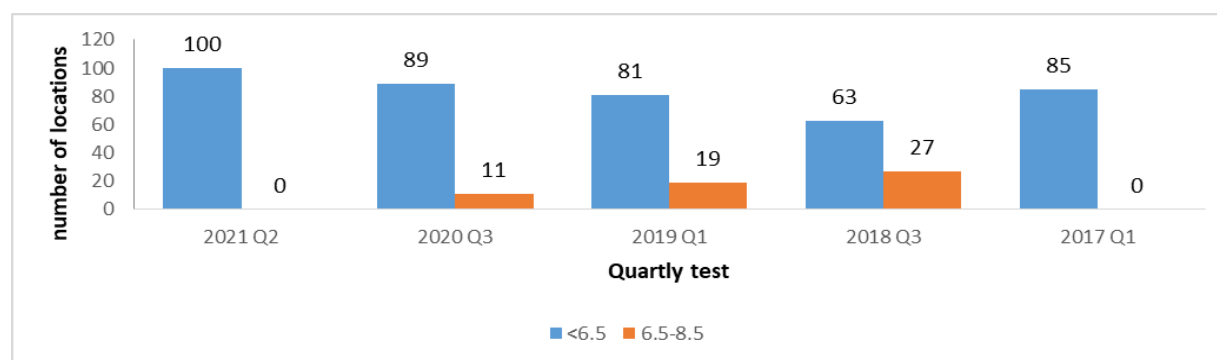
**Chart 12 : Number of locations with pH level below/above WHO guideline of 6.5 to 8.5. in 85 locations in 2017 and 100 locations were tested from 2018 to 2021**

Review of Water Quality Reports by Department of Water Resources during the period under review showed significant number of locations that do not fall within the appropriate PH range. The analysis is presented in the chart below.

As shown in chart 12 above, more than half of the locations water supply have pH levels below the WHO standard. Aeration is carried out to regulate the pH level to an appropriate range. According to NAWEC’s Greater Banjul Area Water Supply System Operating and Maintenance Manual; in case the pH value after aeration is not yet sufficient, lime dosing is applied for further pH adjustment. Therefore, the main purpose of lime dosing is to raise the pH level of water and precipitate the ions (e.g calcium, magnesium, and iron) that cause hardness in water<sup>53</sup>.

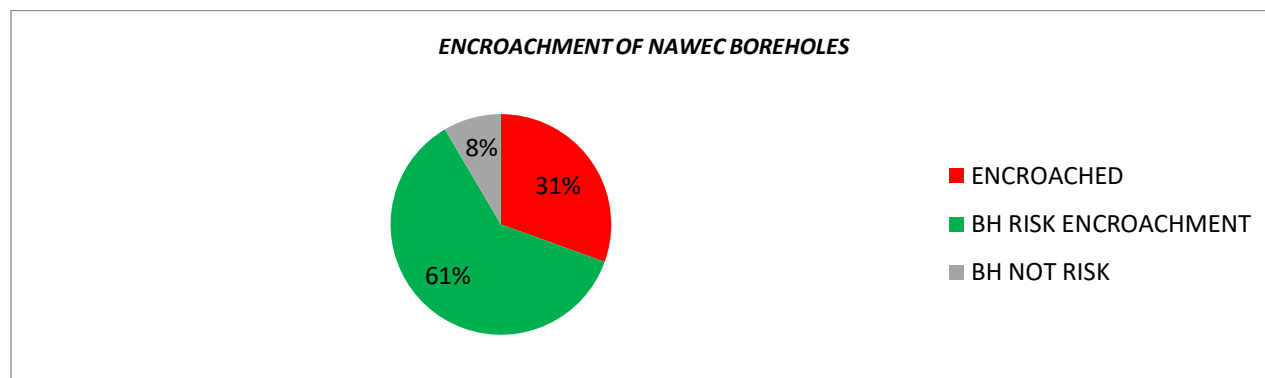
**Chart 13: Percentage of boreholes encroached, those that are on risk and those that are free from encroachment.**

According to the Deputy Director of DWR, human activities such as the digging of toilets and soakaways deeper than two meters, and improper waste disposals by encroachers lead to borehole contamination by nitrate. However, Fajara Treatment Plant is getting some of its water supply from Sukuta Treatment Plant. Additionally, NAWEC does not have any nitrate treatment procedure in place to reduce the level of nitrates in its water. The chart below shows the percentage level of boreholes encroached.

**Encroached:** We discovered that 31% of the NAWEC boreholes shared a fence with residents.
