NATIONAL AUDIT OFFICE OF THE GAMBIA

PERFORMANCE AUDIT REPORT

**THE PROVISION OF WATER IN URBAN, PERI-URBAN AND
PROVINCIAL GROWTH CENTRES BY NAWEC**

NOVEMBER 2022

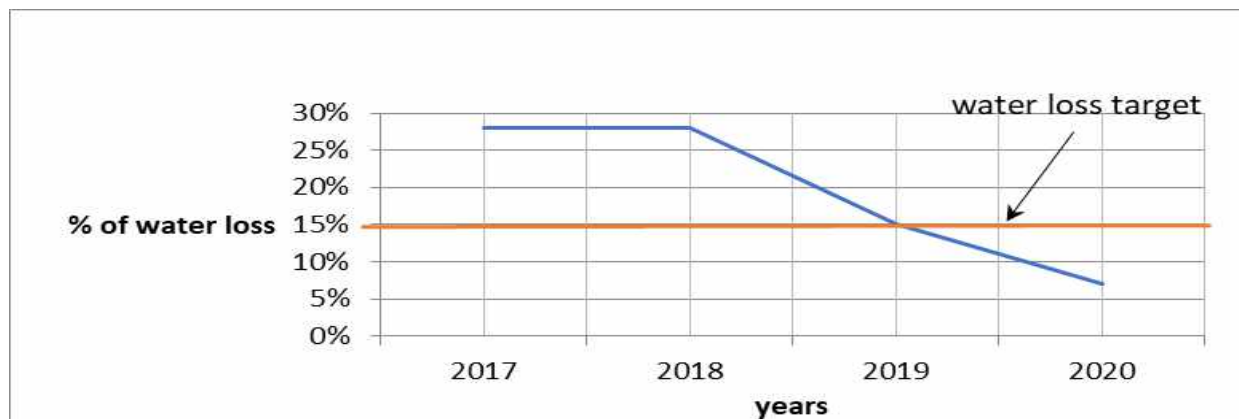
Chart 5: Amount of water loss between 2017 and 2020 ³⁷

From the review of the water production figures provided by NAWEC Water Division, we noted that the company has improved on mitigating water losses to meet its 15% target. The trend over the years is shown in the chart below.

From the chart above it can be seen that from 2017 to 2020, the water loss percentage had decreased from 28% to 7%. However, it is important to note that these production figures were based on estimates because only about half of the boreholes were metered correctly as highlighted in section 4.2.2. This could have an impact on the accuracy of the reported water losses.

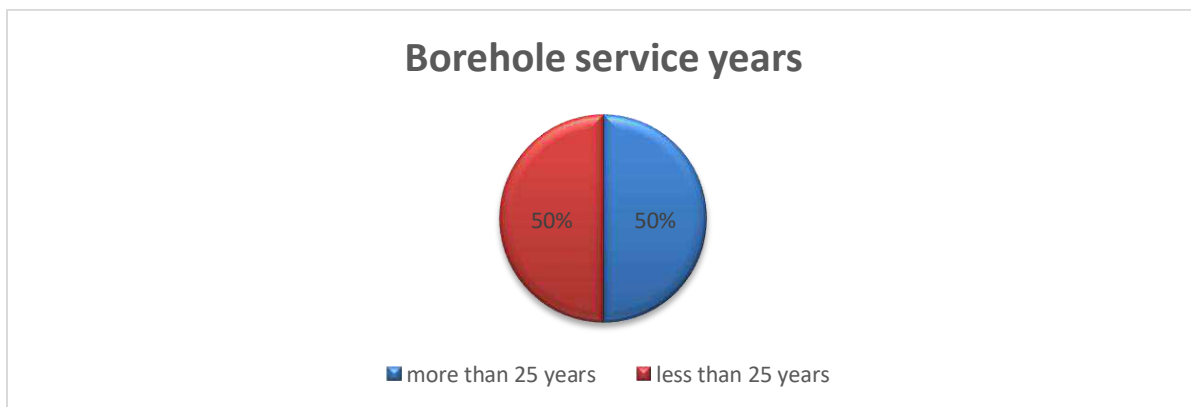
Chart 9: Borehole service years of 74 boreholes.

This was due to the company's failure to establish strategies for replacing old infrastructures. Corroded aged infrastructures pose a high risk of failure, resulting in service interruptions and water quality with a bad taste, colour and contamination. **Appendix 8:** Showing 74 boreholes and their ages their ages.

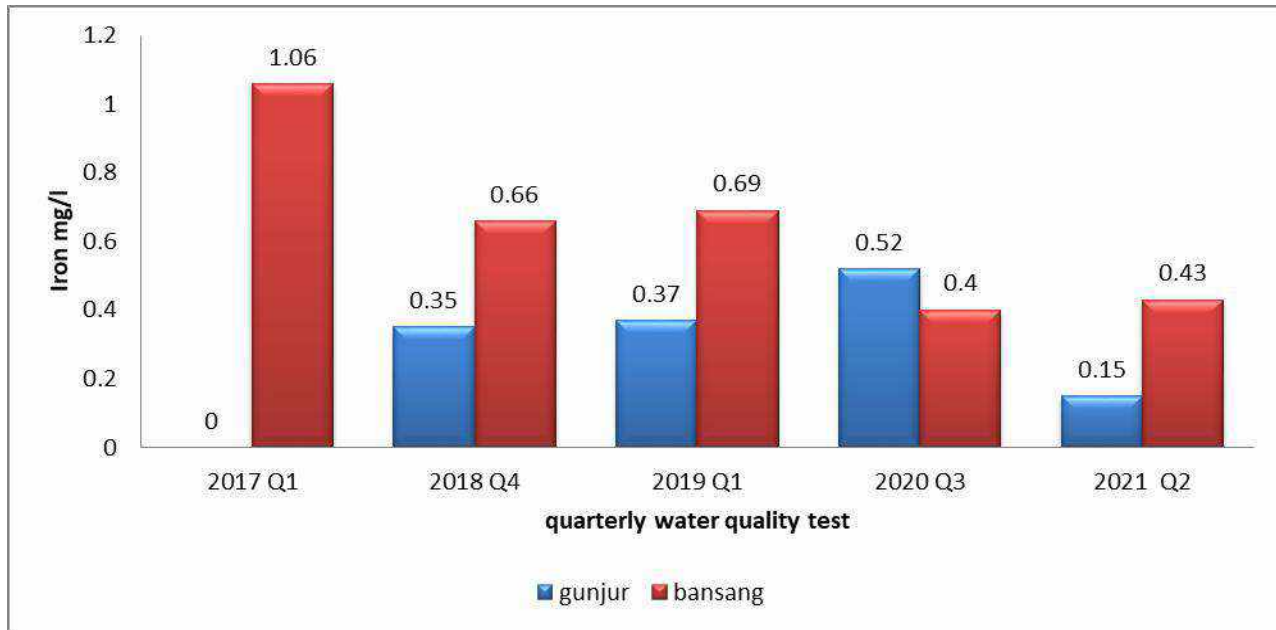
Chart 10: Iron content in the water supplied to Bansang and Gunjur

issue. Additionally, in an attempt to reduce the high levels of iron in Gunjur's water supply, NAWEC decommissioned one of the boreholes with high iron content in Gunjur, but no iron filtration system was installed in Gunjur's Water Treatment Plant. However NAWEC said they plan on taking water from another source mainly Busuranding.

The review of a sample of Quarterly Water Quality Test Reports by DWR during the period under review revealed that, despite the iron filtration system in Bansang, the water in Bansang continued to contain high levels of iron above the WHO standard for drinking water quality. Meanwhile in Gunjur, the iron content has been higher than the acceptable level in 2018 to 2020. However, in 2021 both the first and second quarter Water Quality Test Reports by DWR showed that the iron content in the water sample tested from Gunjur were below the acceptable level.

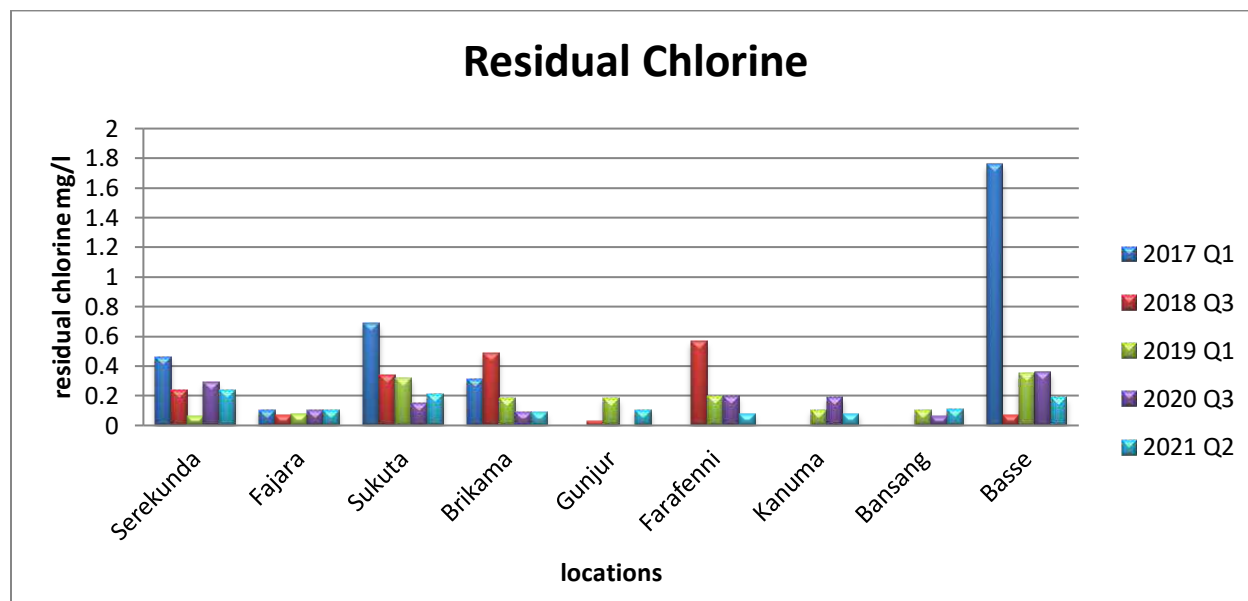
Chart 11: Residual chlorine test result in 85 locations in 2017 and 100 locations from 2018 to 2021.

Review of a sample of the Quarterly Water Quality Monitoring Reports prepared by the Department of Water Resources between 2017 to 2021 showed that an average of 76% of 100 locations tested did not meet the required minimum standard of residual chlorine in the water samples. Analysis of 5 samples of quarterly water quality tests presented is in the chart below.

Further analysis of the quarterly water test results during the period under review showed that the water sample of an average of 16 locations had no residual chlorine.

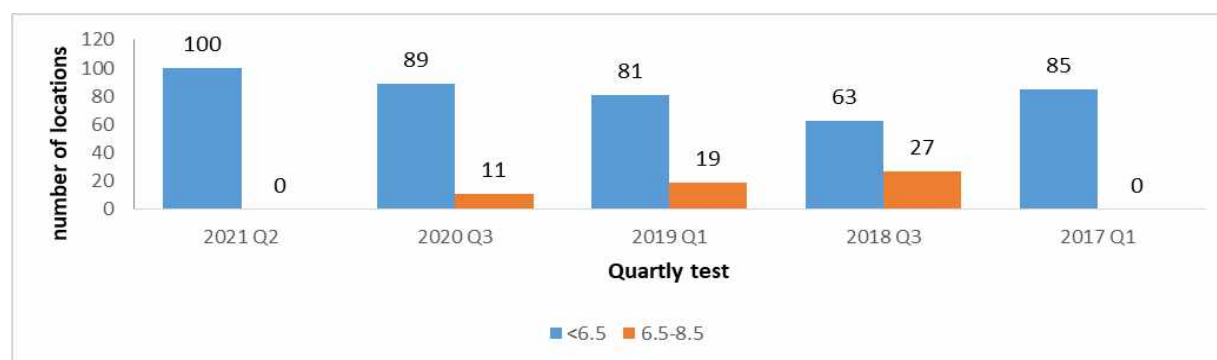
Chart 12 : Number of locations with pH level below/above WHO guideline of 6.5 to 8.5. in 85 locations in 2017 and 100 locations were tested from 2018 to 2021

Review of Water Quality Reports by Department of Water Resources during the period under review showed significant number of locations that do not fall within the appropriate PH range. The analysis is presented in the chart below.

As shown in chart 12 above, more than half of the locations water supply have pH levels below the WHO standard. Aeration is carried out to regulate the pH level to an appropriate range. According to NAWEC’s Greater Banjul Area Water Supply System Operating and Maintenance Manual; in case the pH value after aeration is not yet sufficient, lime dosing is applied for further pH adjustment. Therefore, the main purpose of lime dosing is to raise the pH level of water and precipitate the ions (e.g calcium, magnesium, and iron) that cause hardness in water⁵³.

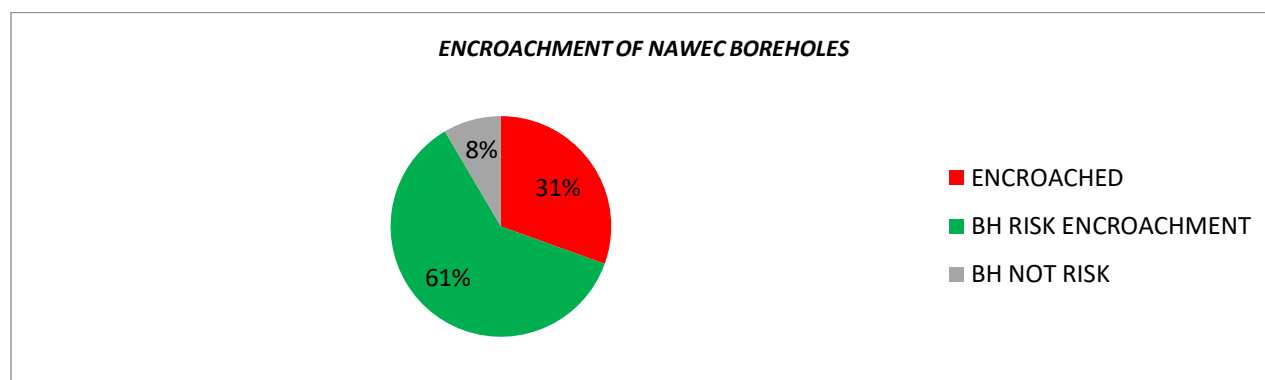
Chart 13: Percentage of boreholes encroached, those that are on risk and those that are free from encroachment.

According to the Deputy Director of DWR, human activities such as the digging of toilets and soakaways deeper than two meters, and improper waste disposals by encroachers lead to borehole contamination by nitrate. However, Fajara Treatment Plant is getting some of its water supply from Sukuta Treatment Plant. Additionally, NAWEC does not have any nitrate treatment procedure in place to reduce the level of nitrates in its water. The chart below shows the percentage level of boreholes encroached.

Encroached: We discovered that 31% of the NAWEC boreholes shared a fence with residents.
